Evaluation of the Energy Performance and Design Process of the Thermal Test Facility at the National Renewable Energy Laboratory

P. Torcellini, S. Pless, B. Griffith, and R. Judkoff

National Renewable Energy Laboratory
1617 Cole Boulevard, Golden, Colorado 80401-3393
303-275-3000 • www.nrel.gov

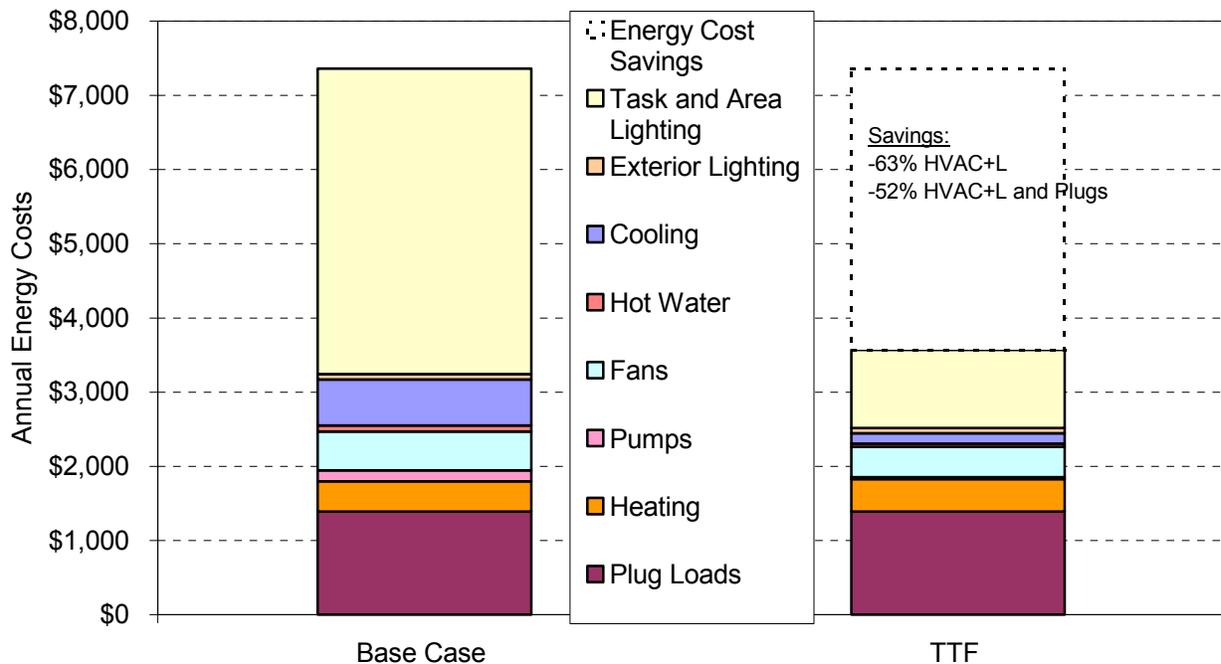
Figure ES-1 Annual site energy costs of TTF compared to base case for a typical meteorological year (calibrated simulation)

The TTF cost 63% less per year to heat, ventilate, cool, and light than a code-compliant, base-case building. The base-case building discussed here complied with the requirements of the Code of Federal Regulations 10 CFR 435 (DOE 1995) based on the American Society of Heating, Refrigerating, and Air-Conditioning Engineers (ASHRAE) Standard 90.1-1989 (ASHRAE 1989), yet with more stringent lighting power density requirements.

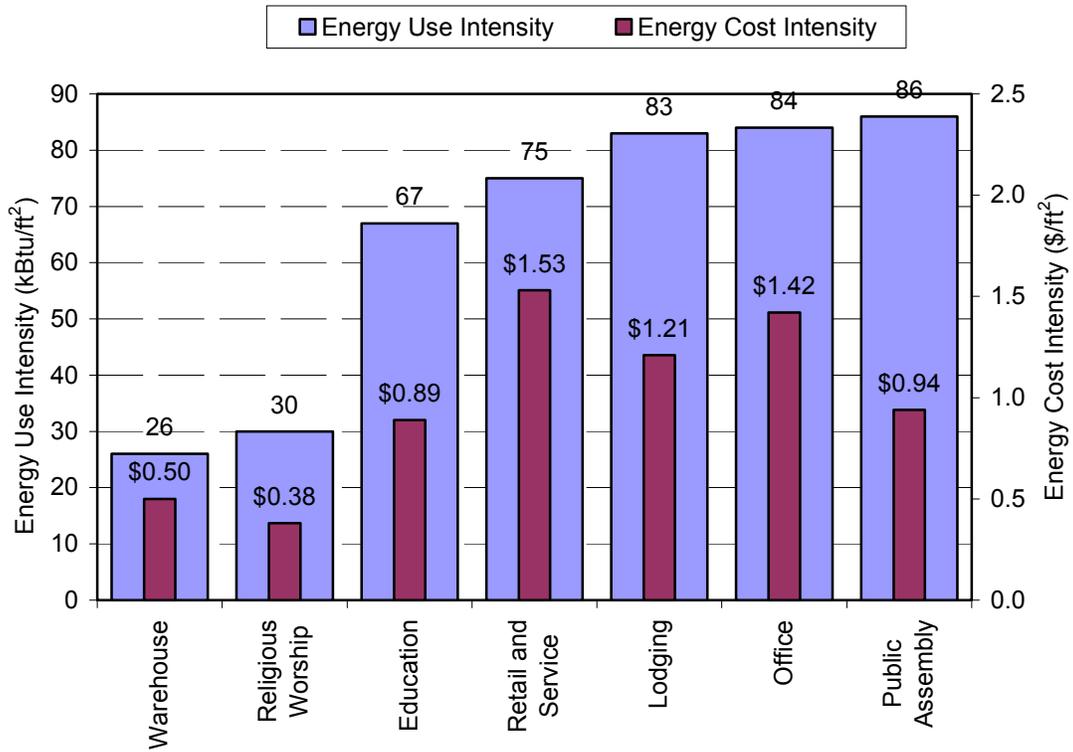
Figure 2-1 Site energy use and cost intensity by building type for commercial buildings in the West

Figure 2-1 shows the energy use and cost intensity over the range of building types for commercial buildings in the West. Figure 2-2 shows the energy end-use distribution in typical office buildings. Note that lighting is the largest end use in office buildings, with space heating and office equipment the next-largest end uses.

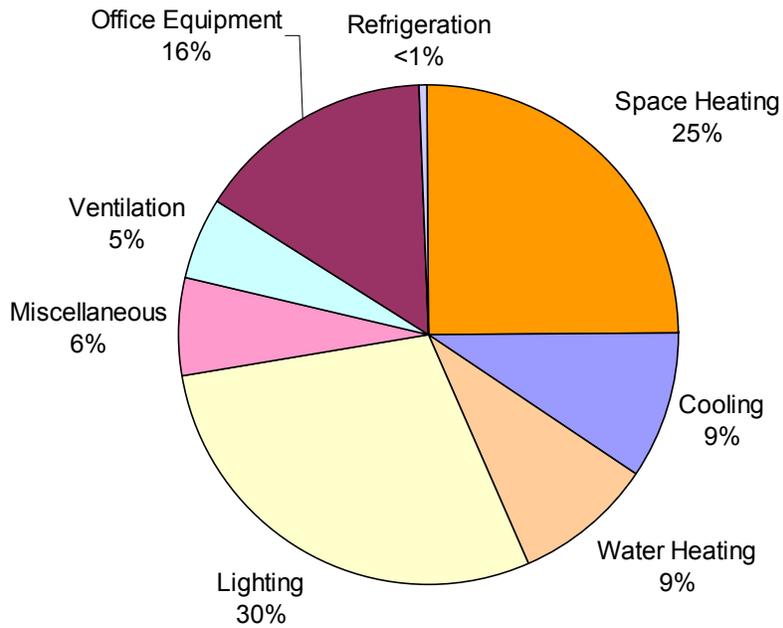
Figure 2-2 U.S. office building site energy consumption by end use, 1995

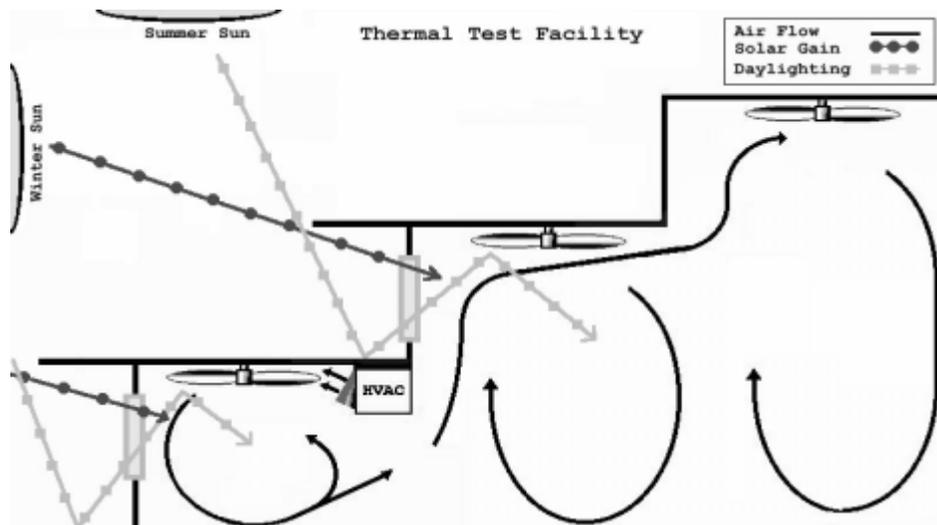
Figure 3-2 Early conceptual schematic for integrating low-energy daylighting, passive solar, and air distribution

Designers proposed a stair-step building design to meet the specified height requirements. Unlike a standard box configuration, the stair-step design integrated daylighting and passive solar features, while minimizing the volume of the space. It also reduced HVAC system capacity requirements. In addition, the design promoted natural convection for air distribution and a reduced volume of conditioned air. Complete air mixing could then be achieved by operating supplementary low-energy ceiling fans. Figure 3-2 diagrams the early ideas for how the conceptual building could integrate daylighting, passive solar, and efficient air distribution. Evaporative cooling was suggested at this early stage with designers noting that a direct/indirect evaporative cooling system could deliver 55°F (13°C) dry-bulb supply air at ASHRAE 1% cooling design conditions for Denver and that a 100% outdoor air cooling would improve air quality inside the building.

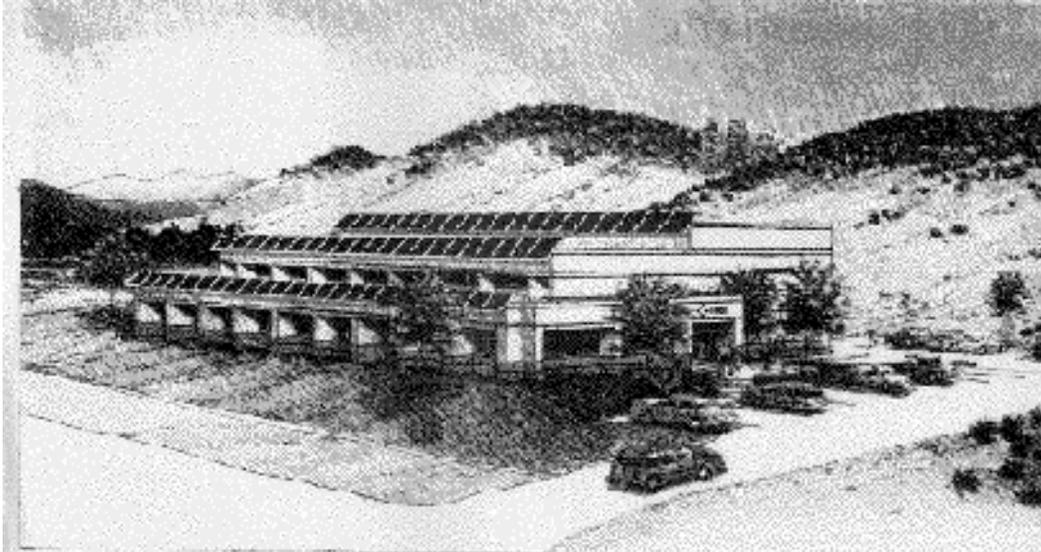
Figure 3-3 Rendition of the conceptual design for TTF

Figure 3-3 is an artist's rendition of the conceptual design for the TTF, which includes solar-electric panels located along each of the TTF's stair-stepped tiers. Fenestration is primarily located on the south facade in the form of view-glass and clerestory windows; very little fenestration was placed on the east, west, and north facades. Architectural overhangs and fins integrated into the design of the building's exterior managed heating and cooling loads, depending on the season and angle of the sun. The conceptual design included a central core that incorporated the conference room, restrooms, closets, and kitchenette. The mechanical room was located at the building's eastern perimeter, and the entrance was situated on the east side.

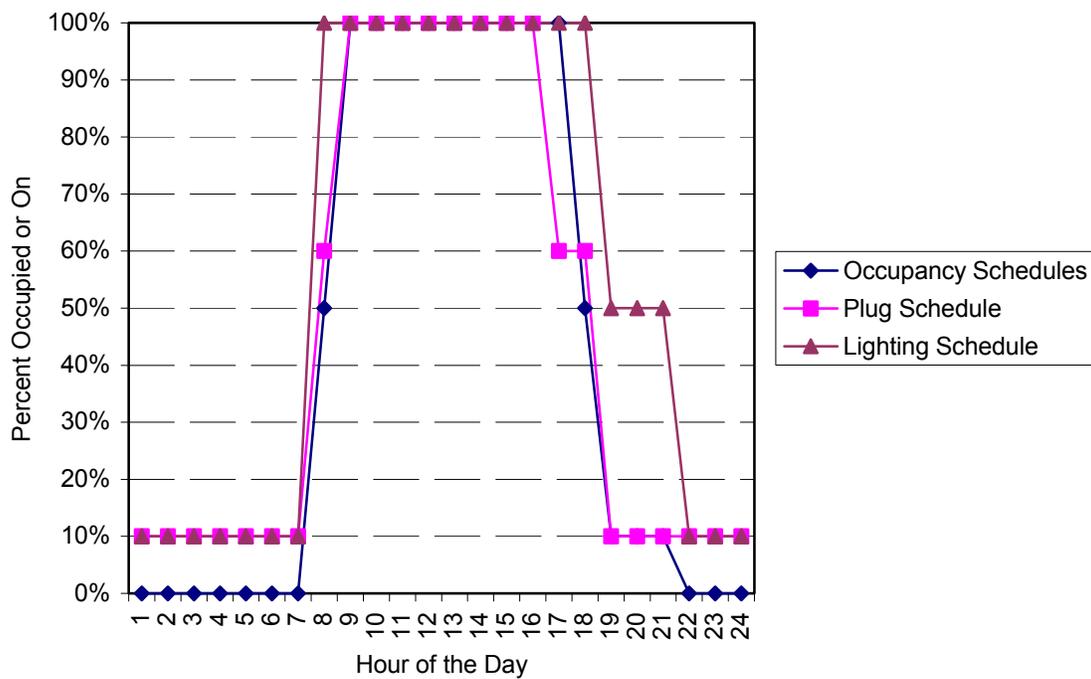
Figure 3-4 Base-case model schedules

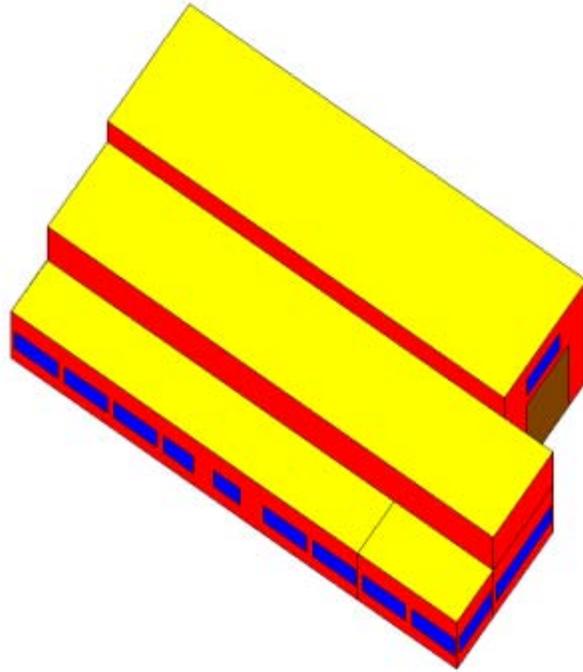
Figure 3-5 Base-case energy model geometry

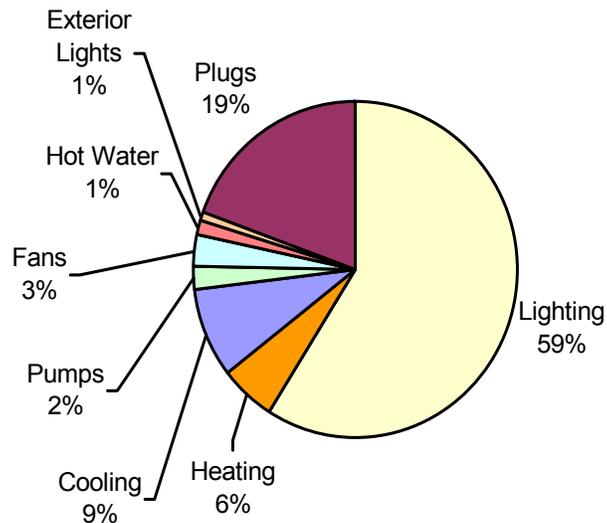
Figure 3-6 Base-case model results for energy operating costs

Figure 3-6 shows the breakdown of annual energy operating costs obtained from the DOE-2.1E simulation of the base-case building model. A table of the simulated base-case and as-built energy costs is included in Section 4.9, Table 4-7. Equipment loads (plug loads) were not included in Figure 3-6 because these loads form part of the building use and should not be considered as part of a low-energy design. However, a plug-load electrical density value of 0.75 W/ft^2 (8.1 W/m^2) was included in the models because of its influence on building heating and cooling. In this type of analysis, energy use pertains to services that the building provides to the occupants through HVAC and lighting equipment (HVAC+L). Energy costs were calculated using an electricity cost of $\$0.0248/\text{kWh}$, with an on-peak demand charge of $\$6.15/\text{kW}$ and an off-peak demand charge of $\$3.75/\text{kW}$. Natural gas costs were $\$0.385/\text{therm}$. The TTF is located on a centrally metered site. The rates are based on NREL utility bills at the time of the design.

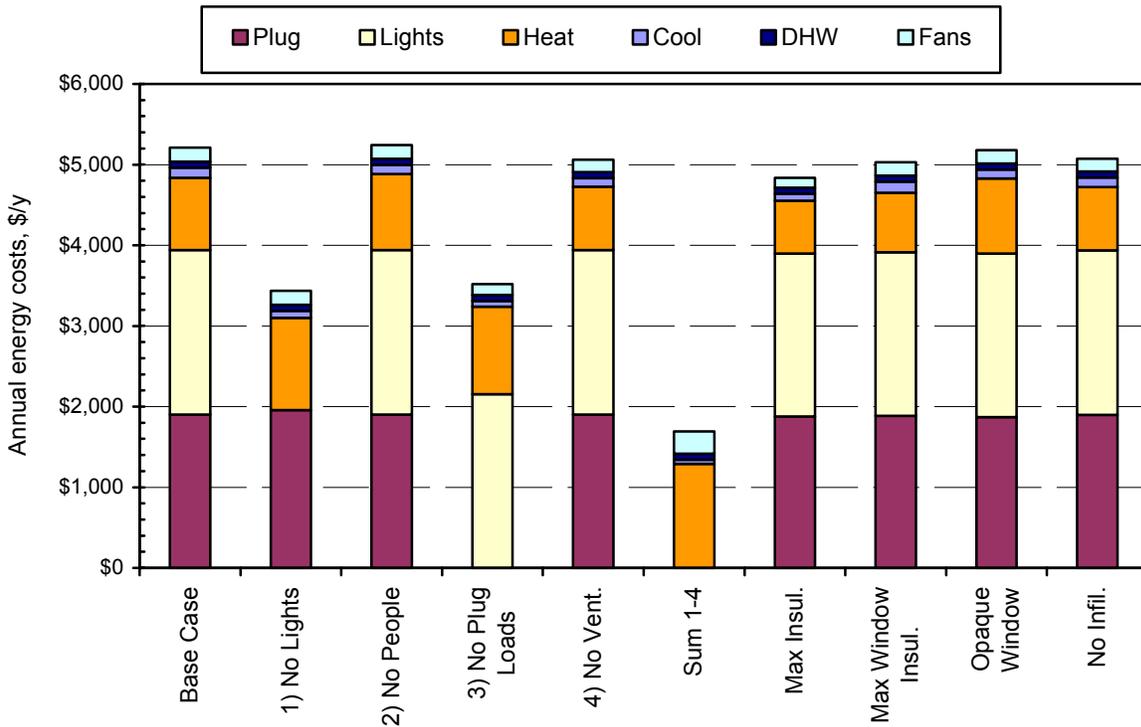
Figure 3-7 Elimination parametric results for energy cost

Figure 3-7 shows results for annual energy operating costs from the elimination study. Reducing the use of electric lighting offered the largest potential for saving energy. This energy-saving potential extended to the cooling load. However, eliminating electric lights increases heating energy, which is evident by comparing the amount of heating in the first two cases shown in Figure 3-7. Eliminating plug loads has similar consequences, but these loads are a function of the user and cannot be incorporated into the design of the building. Finally, minimal energy savings resulted from reducing ventilation, solar gains, infiltration, and maximizing the building's wall insulation.

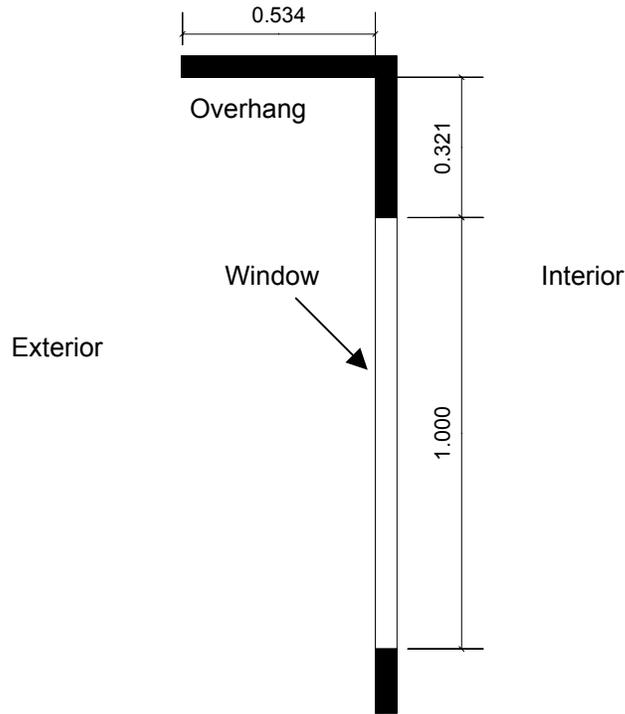
Figure 3-8 Overhang ratios for Boulder, Colorado, used for the starting point for the TTF analysis

the building, the window overhangs were sized from the Solar Radiation Data Manual (Marion 1995), as shown in Figure 3-8. Insulation levels and lighting design remained the same as the base-case model.

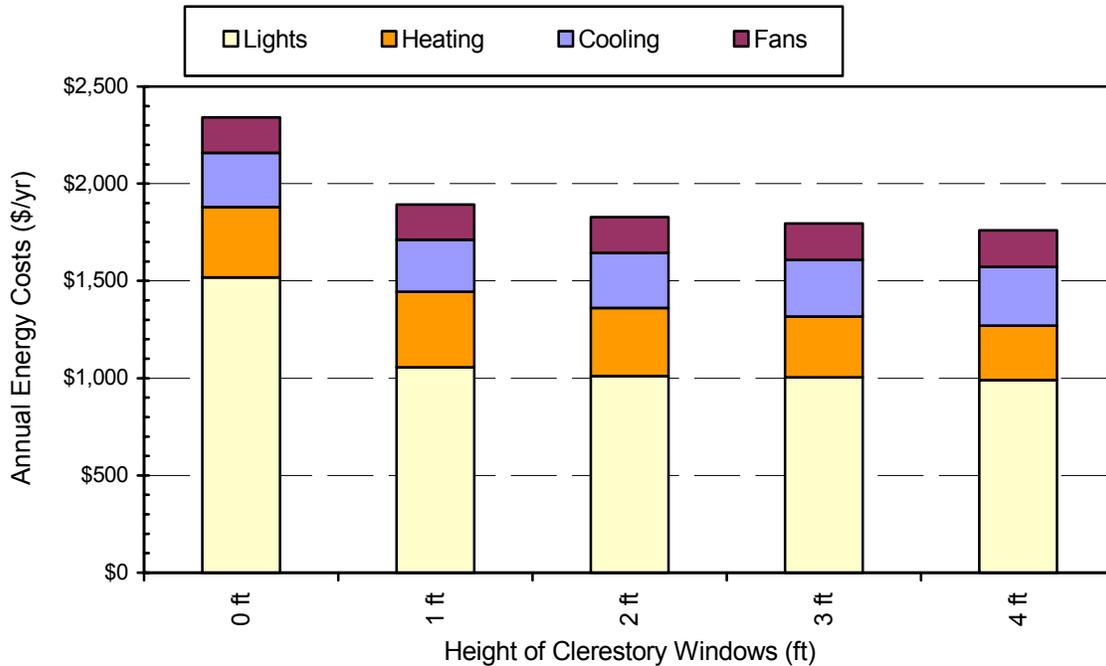
Figure 3-9 Impact of clerestory window height on annual energy cost

Figure 3-9 shows partial results of the variation of clerestory height on the energy consumption for the building. The reduction of lighting energy nearly saturated at 3 ft (0.9 m). Additional increases in window area came with unwanted solar gains and increased heating and cooling loads. Note that changes to the later variables were small compared to the lighting contribution, which was consistent with the parametric and base-case analyses. At a clerestory height greater than 2 ft (0.6 m), the total energy consumption was almost independent of window size. The design team chose a final clerestory height of 3 ft (0.9 m) for energy cost reduction and architectural appeal. Although the cost of a 3-ft (0.9-m) window was slightly more than a 2-ft (0.6-m) window, the design team favored the increased architectural appeal. In addition, this window size fit well with the programmatic consideration for the step height and construction of the building.

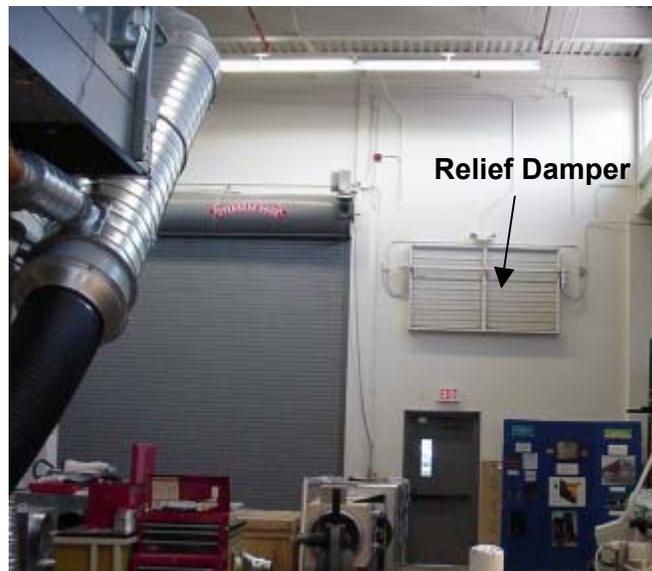
Figure 3-10 Relief damper location on east high-bay wall

The relief damper for removing surplus air from the building during cooling was not positioned as intended. According to the plans, this damper was to be placed “as high as possible” on the east high-bay wall. The plans, however, showed this damper located at the same height as the top of the garage door. The design intent was to relieve the warmest air in the building in order to maximize the effectiveness of heat extraction during cooling. The relief damper is visible to the right of the roll-up door in the photograph shown in Figure 3-10. Instead, the damper was placed at mid-height on the high-bay east wall, causing warm air to be trapped in the upper half of the high-bay area. It was considered too difficult and expensive to relocate the damper after installation. Because the definition of “as high as possible” was not defined beforehand, there was no leverage with the contractor to move the damper. Locating the damper higher on the wall would have allowed natural ventilation to be used as a first stage of cooling. No fluid analysis was done on the building, so the impact of this change is unknown and is beyond the scope of this evaluation.

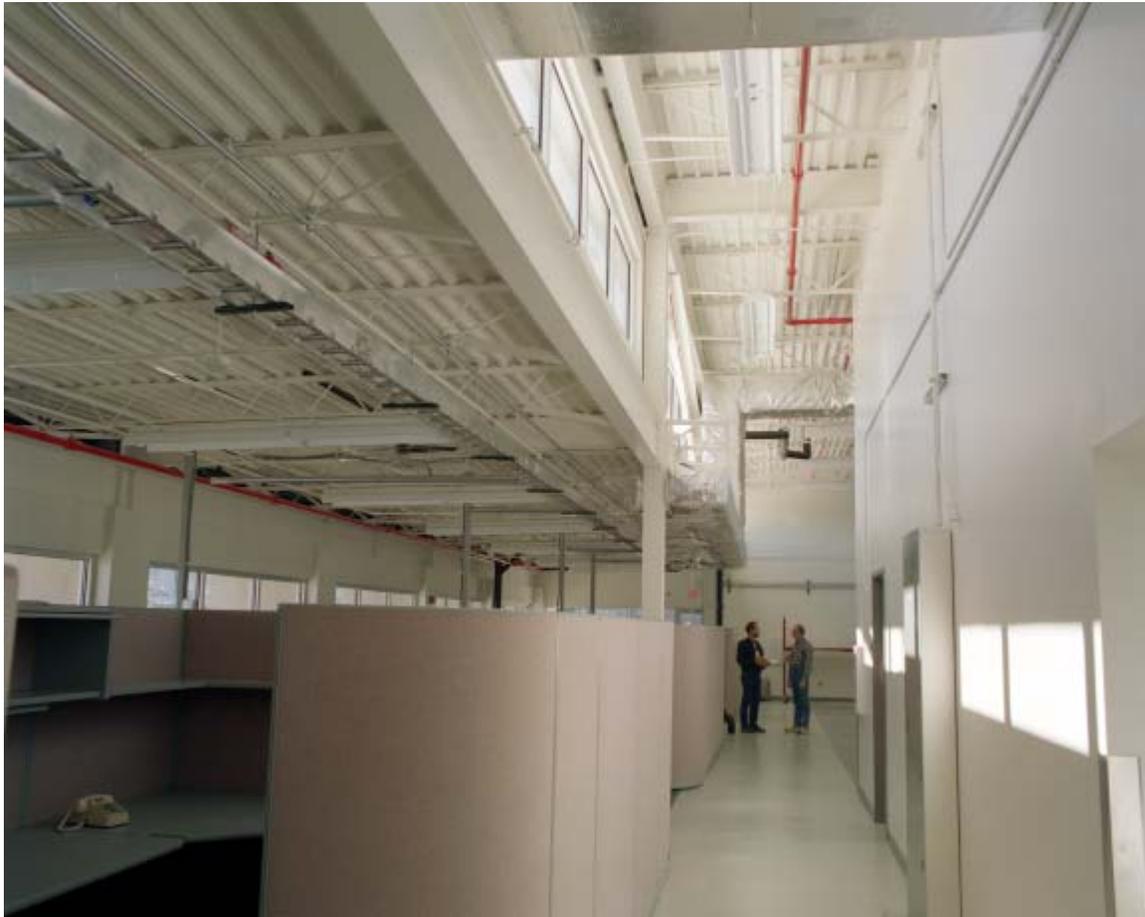
Figure 3-11 Mid-bay clerestory daylight at low-sun angles before installation of blinds

To control low-solar angle glare issues, NREL added horizontal blinds to the interior of the mid-bay clerestory windows. The building was designed to provide light scattering off the light-colored mid-bay wall, but the intensity of the sunlight resulted in glare problems for nearby office cubicles. Figure 3-11 shows the direct sun on the mid-bay wall. Figure 3-12 shows the mid-bay with the blinds adjusted to eliminate the direct glare into the space. Glare is not a problem in the summer months when overhangs block direct gain. Currently, the clerestory blinds are adjusted twice a year, once during the fall and again in the spring. Occupants adjust window blinds on view windows in the conference room and south offices as needed. In addition, the nature of the experimental work in the west mid-bay necessitates no direct gain—which would affect the thermal calibration of the experiments.

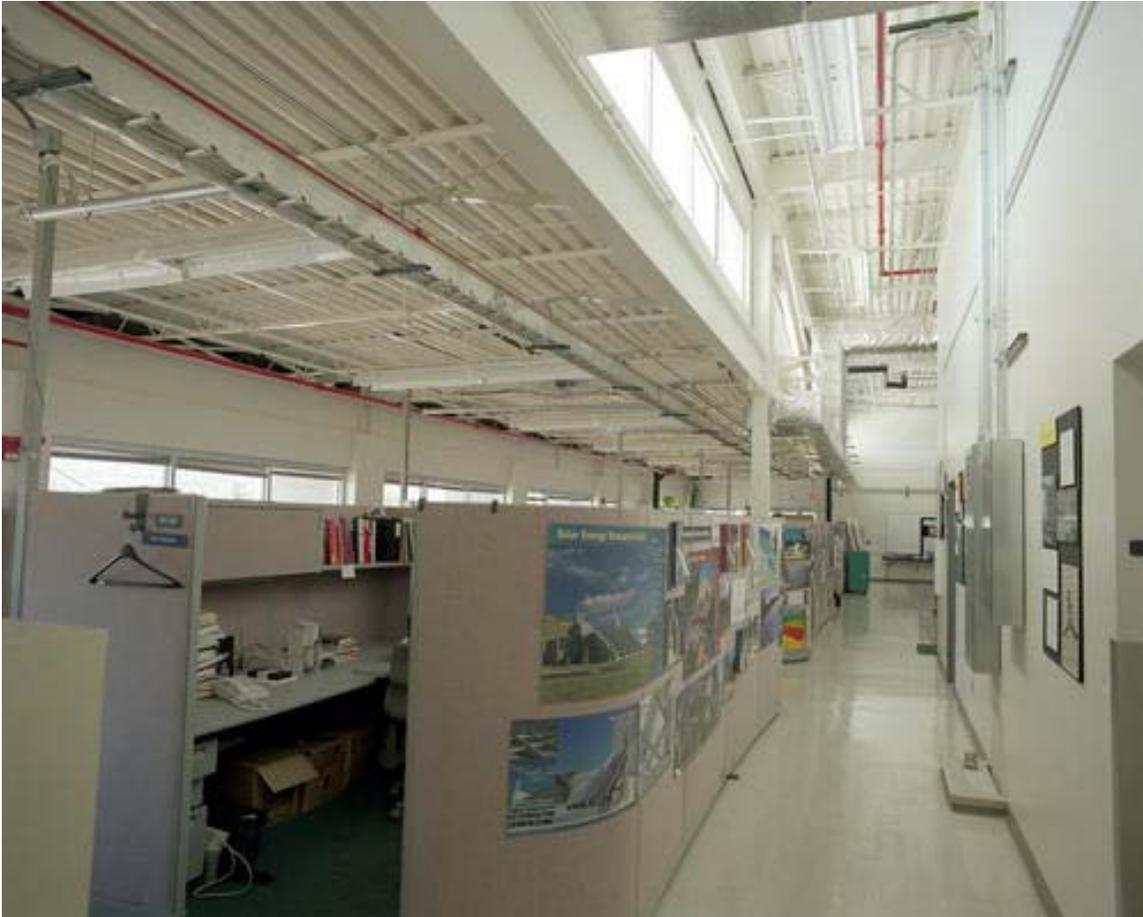
Figure 3-12 Mid-bay clerestory daylight at low-sun angles after installation of blinds

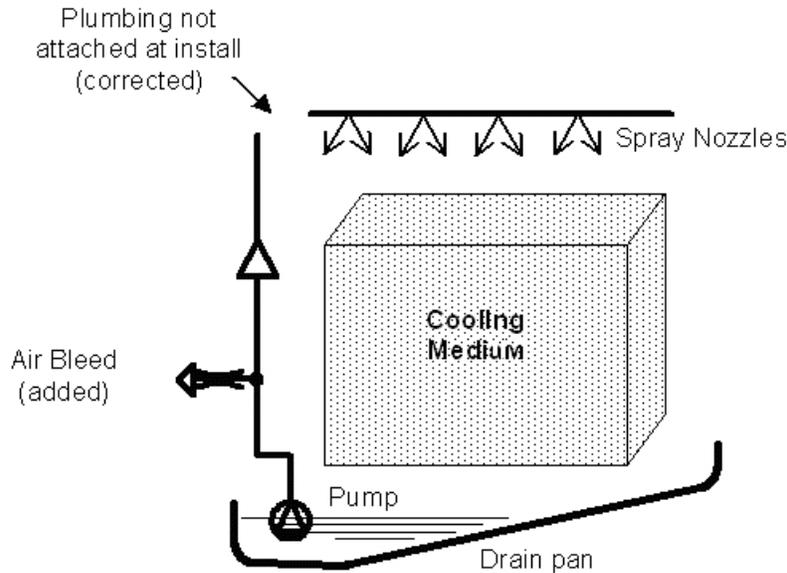
Figure 3-13 Direct evaporative cooler plumb schematic showing problem during construction related to plumbing connection

The direct section of the evaporative cooling unit experienced four separate pump failures. NREL determined that the pumps were not maintaining a prime. Without a satisfactory prime, pumps operated continuously without moving any water and subsequently failed from overheating. A slow air bleed valve was installed downstream of the pump to solve this problem as shown in Figure 3-13.

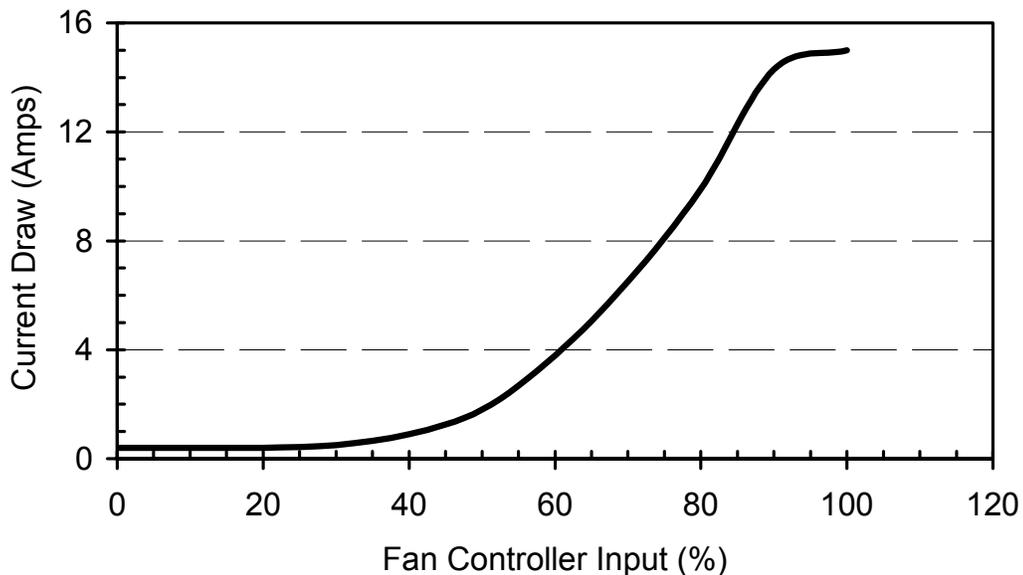
Figure 3-14 Supply fan speed controller input versus current draw

The VAV supply fan curve (Figure 3-14) is characteristic of an energy-saving, variable-speed drive (VSD). When the fan is operated at reduced speeds, it draws less current and reduces energy requirements. However, the ceiling fans and the heat exchanger fans use an inexpensive controller for part-load operation. Figure 3-15 illustrates the variable-speed performance characteristics of the ceiling fan. However, when the same variable-speed controllers were used with ventilation fans within the air-to-air heat exchangers (HEXs), they were shown to be inefficient (Figure 3-16). Because these ventilation fans actually use more energy at lower speeds, NREL disabled the variable-speed control. The fan control is now set at on/off.

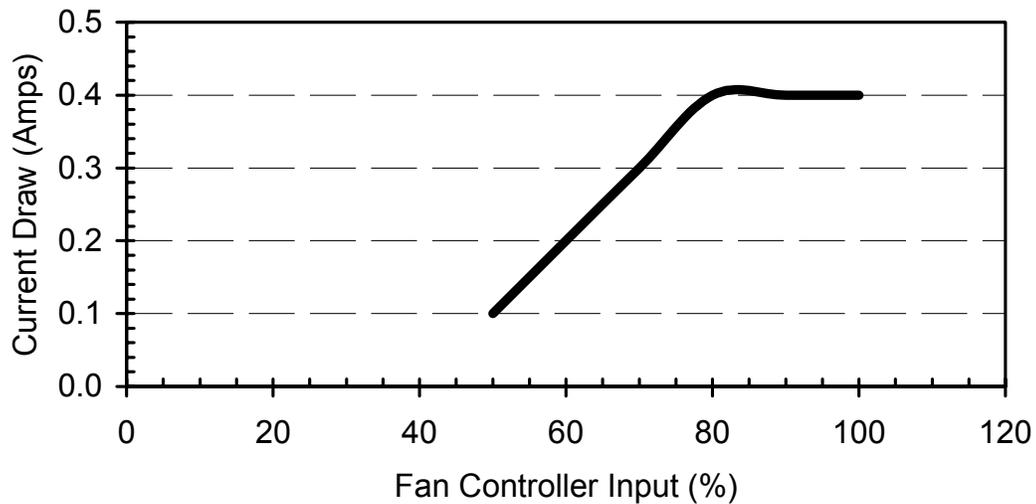
Figure 3-15 Ceiling fan variable-speed controller output versus current draw

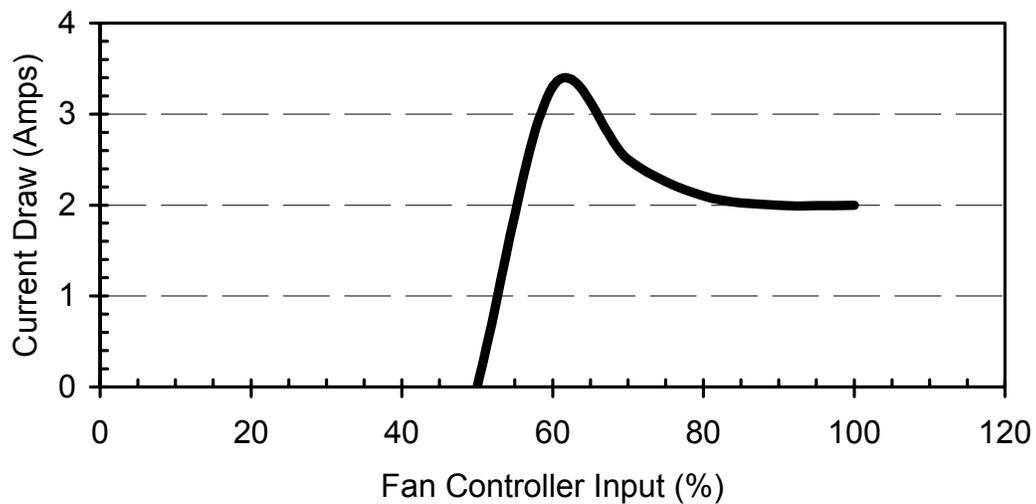
Figure 3-16 Ventilation fan variable-speed controller output versus current draw

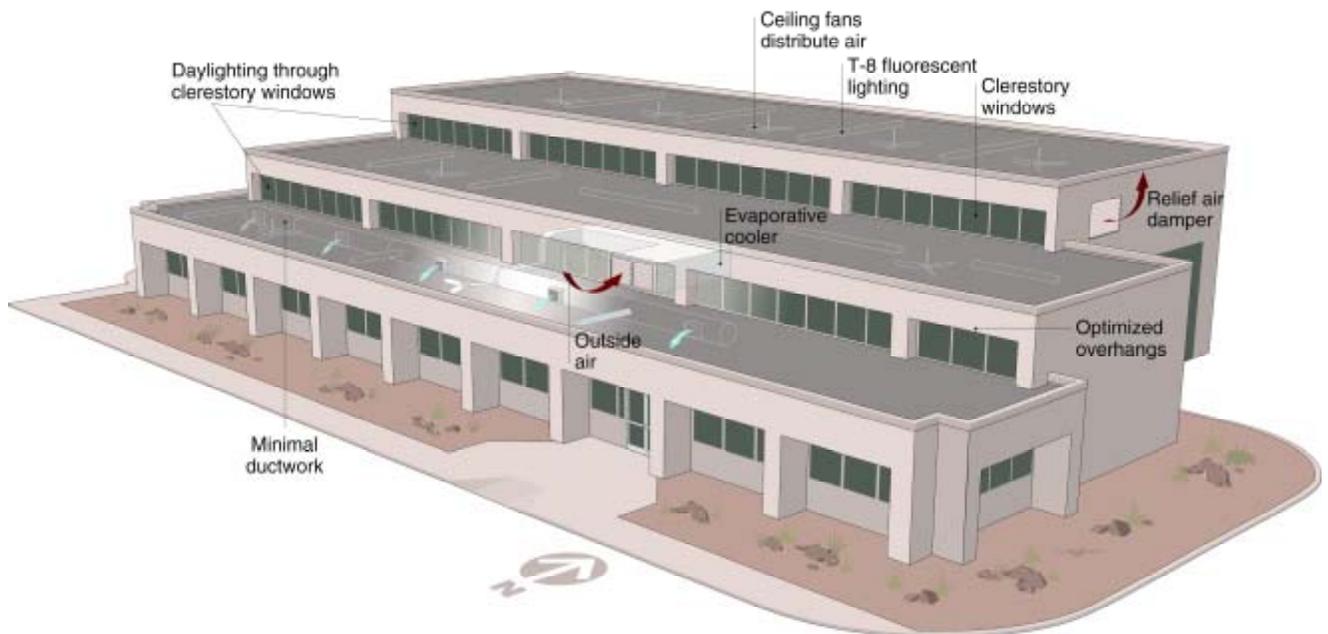
Figure 4-1 Axonometric drawing of the TTF final design

Figure 4-1 shows an axonometric of the building highlighting some of the significant design features that contribute to the energy performance of the building. Table 4-1 summarizes the design features of the building.

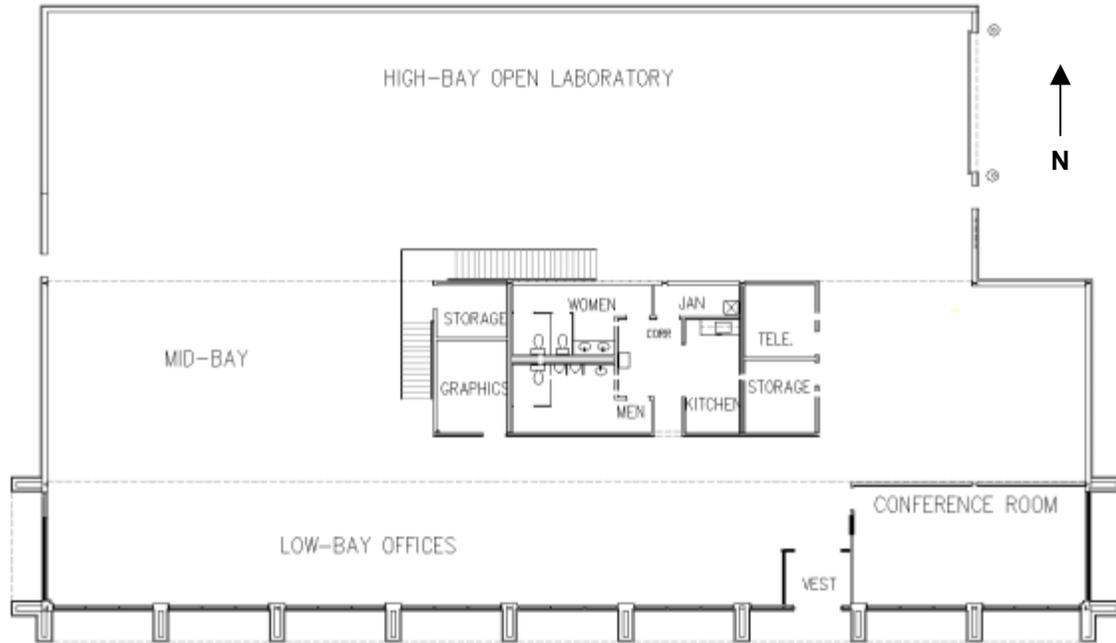
Figure 4-2 As-built floor plan for the Thermal Test Facility

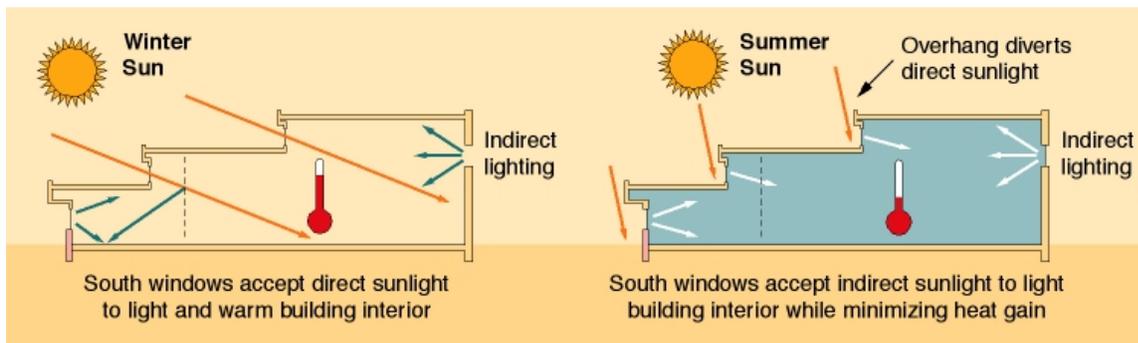
Figure 4-5 Managing solar gains with overhangs

Figure 4-5 illustrates how these overhangs avoid impeding direct solar radiation during the winter months when sun angles are much lower. Fins on the south-facing, ground-level windows were incorporated for aesthetic reasons, rather than as part of the passive solar design. They provide some solar gain relief for the east and west facades of the building as well as some limited glare control on the south facade. Overhang ratios for the view glass and clerestories are shown in Figure 4-6. NREL engineered the north-facing window areas to augment the clerestories. The net result is bi-directional lighting that minimizes the heat transfer through the glazing.

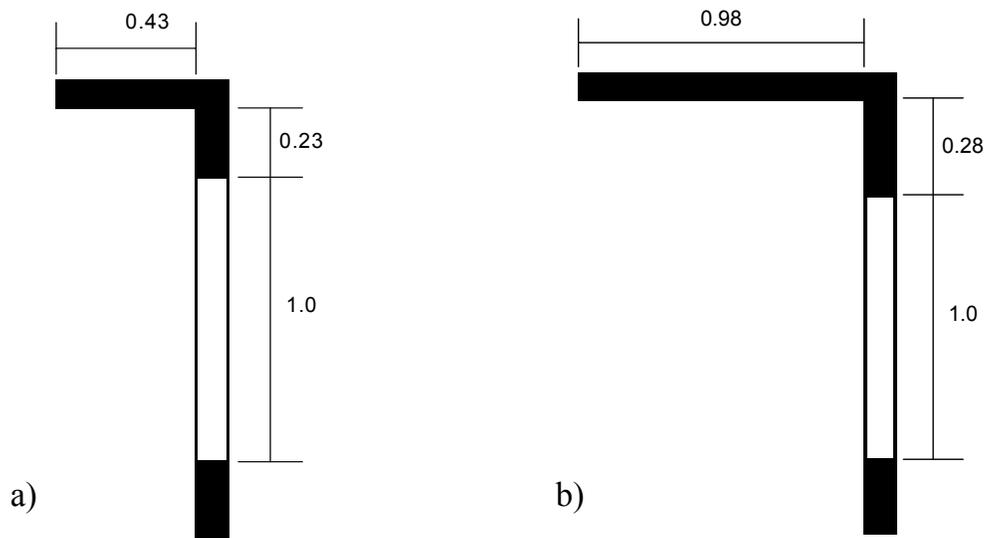
Figure 4-6 Overhang ratios for clerestories (a) and view glass (b)

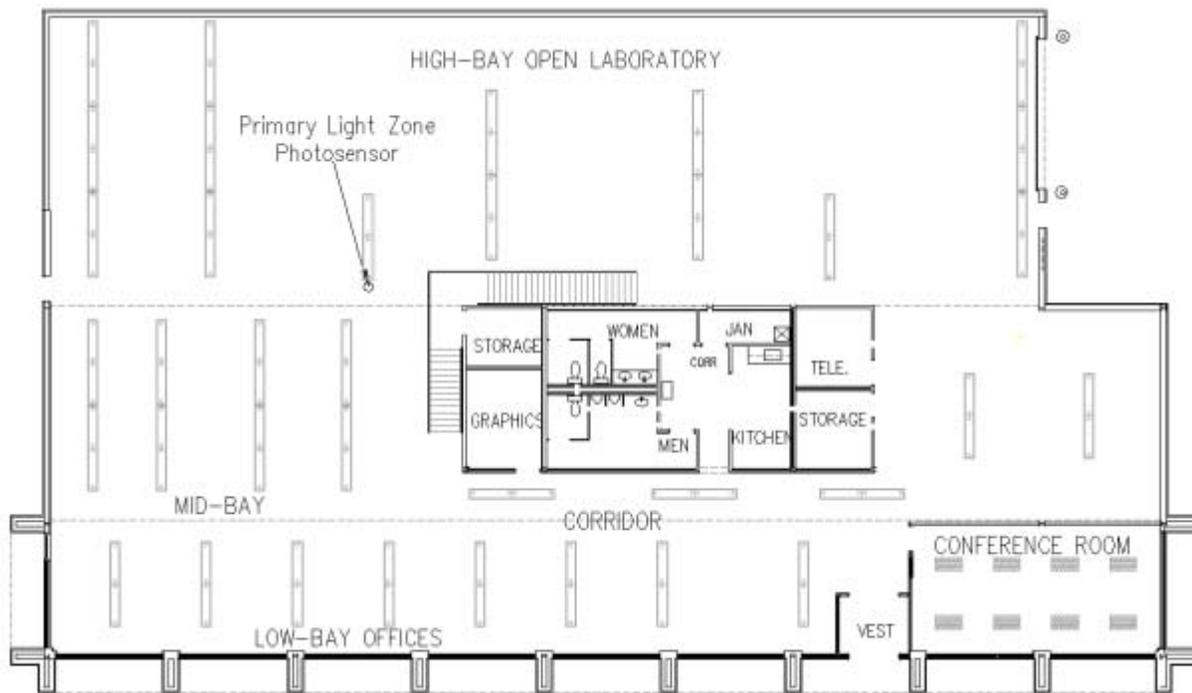
Figure 4-7 Lighting plan

Lighting zones were selected based on occupancy and daylighting. Zones were defined to be parallel to the fenestration. Zones are defined as low-bay east, low-bay west, mid-bay east, mid-bay west, high-bay east, and high-bay west, and the conference room. Additional zones with no daylighting are the men's restroom, the women's restroom, the hallway, and the kitchenette and closets. Lighting zones are shown in the lighting plan in Figure 4-7. It should be noted that portions of these spaces could have been daylighted with opaque glass on the interior south wall opening to the hallway.

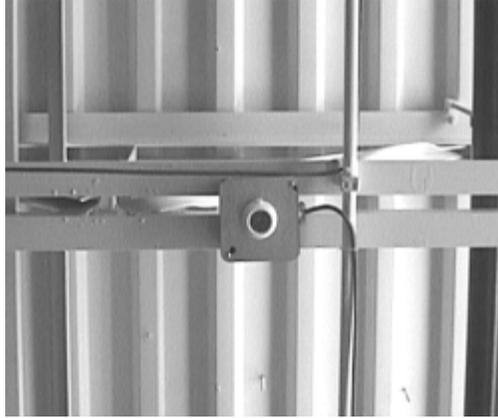
Figure 4-8 Sensor used by the EMS to control electric lighting based on availability of natural daylight

The exception to this control scheme is the hallway located between the offices and service core. This hallway is served by an integrated motion and daylight sensor that provides security lighting for the building; its lights are not connected to the EMS. When the building is not occupied, no lighting is on. As soon as the front door is moved, the security lighting is triggered on, unless there is ample daylighting. It is important to note that security lighting is off when daylighting is available.

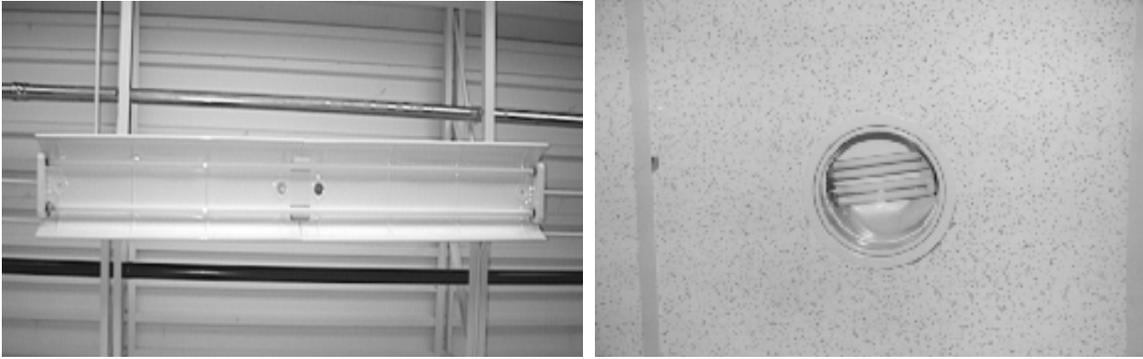
Figure 4-10 Efficient electric lighting luminaires include T-8 (left photo) and CFL can fixtures (right photo)

Figure 4-10 shows the luminaires selected for area lighting; Table 4-2 lists the installed capacities as well as the lighting power density (LPD). These fixtures use T-8 and compact fluorescent (CFL) lamps with an installed power of 7.2 kW. Of this capacity, 72% provides supplemental lighting to day-lit zones; the remaining 28% provides primary lighting to the building's central core. Fluorescent luminaires with electronic ballasts consume roughly 75% less energy than incandescent luminaires with the same output. They also consume roughly 15% to 25% less energy than T-12 fluorescent luminaires with magnetic ballasts. Initially, designers wanted to use high-intensity discharge (HID) lamps for the high-bay areas with 24-ft (7.3-m) ceilings because of concerns about using fluorescent lamps far from the floor. However, because the lights were to be controlled by daylight sensors, they would need to be able to switch on and off quickly. Therefore, the design team chose fluorescents because of the difficulties in starting HID lamps.

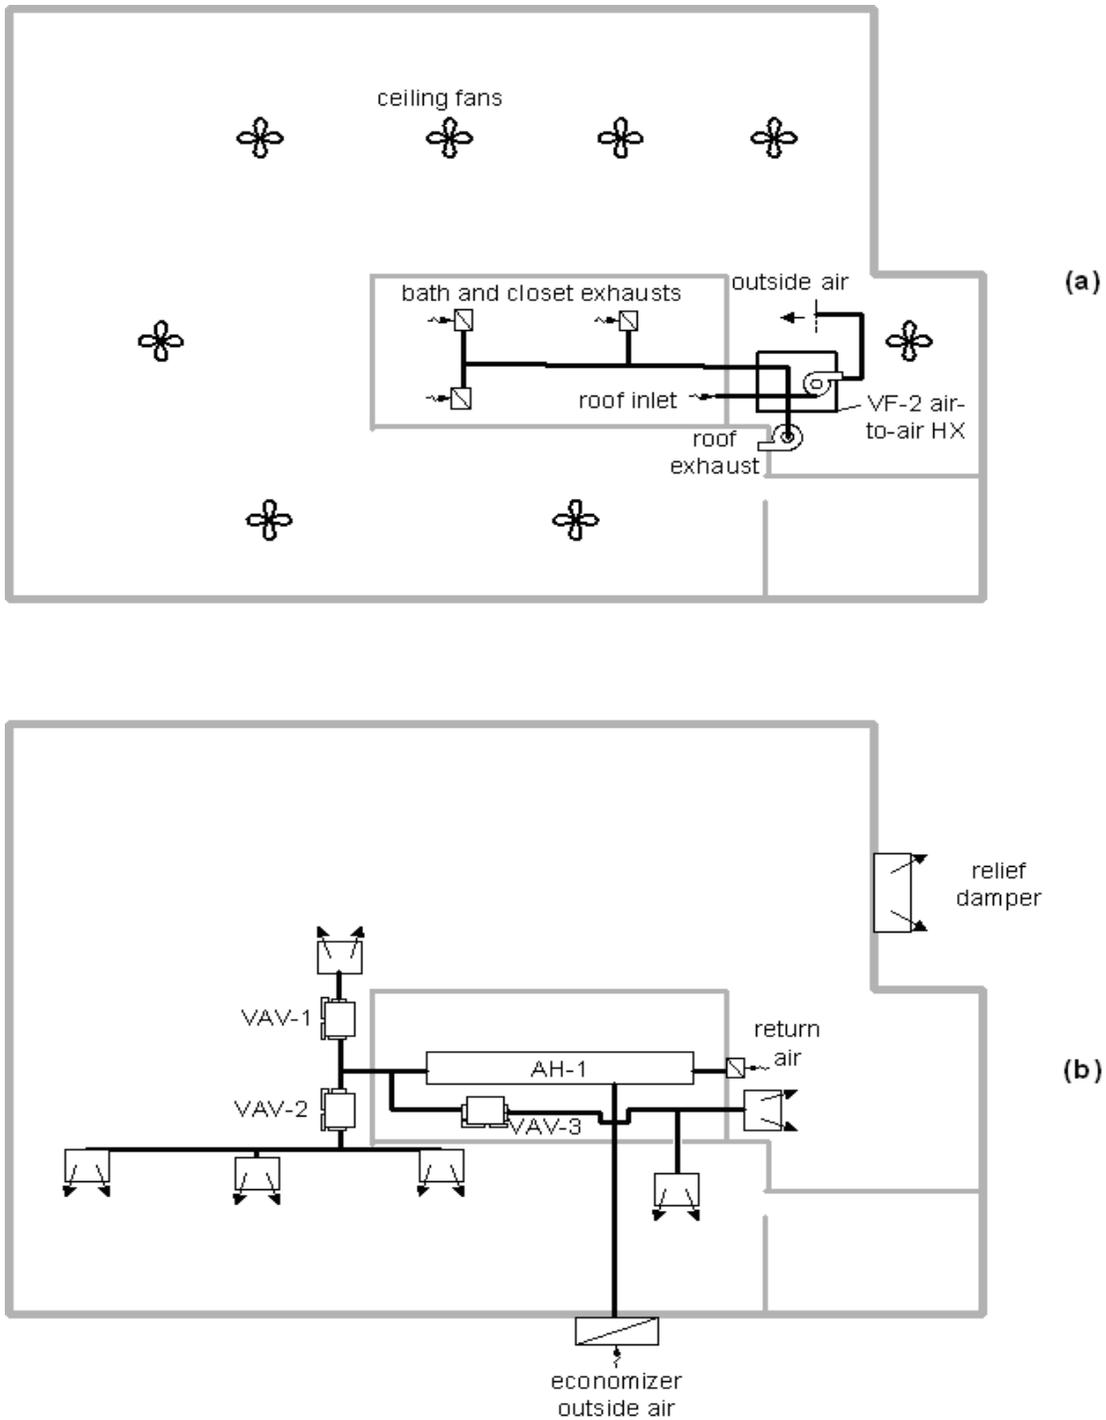
Figure 4-13 Schematics of main building air systems (a) ventilation air system, (b) heating and air-conditioning system

Heating is provided via parallel VAV boxes and hot water is supplied from NREL's central heating plant. The fans in these units operate only when heating is required—note that they had to be reprogrammed to operate in this manner. In this mode, the VAV portion of the box is closed. Note that the tie to the NREL central plan was a requirement for this campus building. An alternative would have been a natural gas fired forced-air condensing furnace.

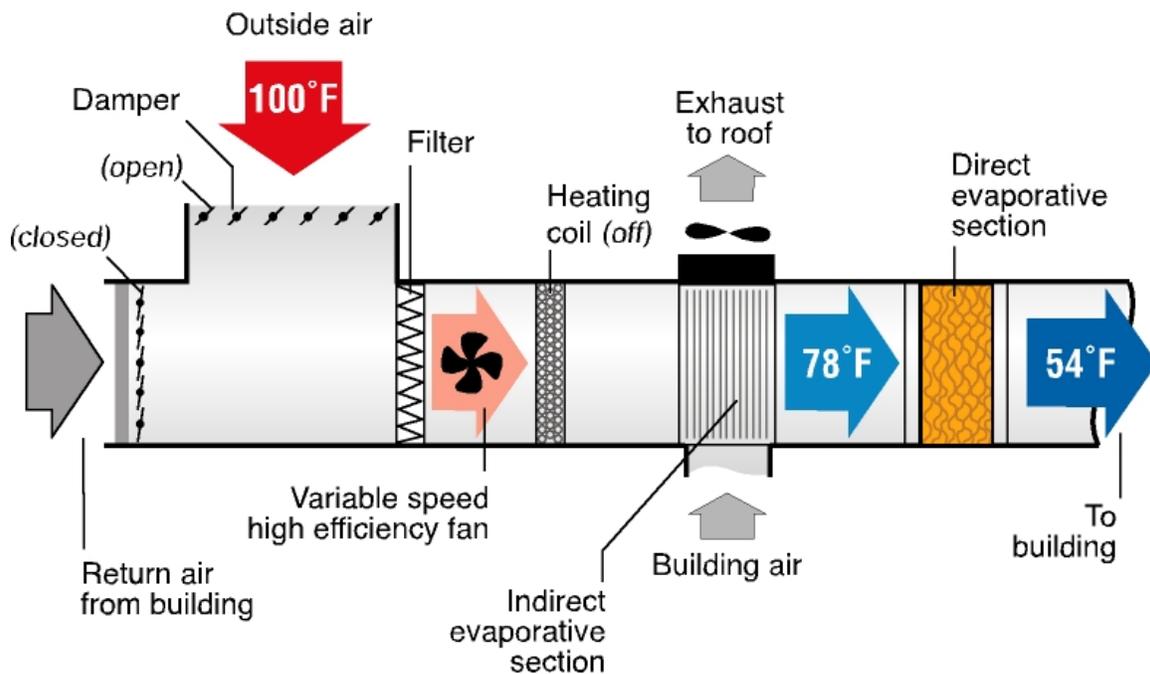
Figure 4-14 Main air handler with indirect/direct evaporative cooling

The main air handler is used only for cooling; it is turned off when cooling is not needed. There are four different operating modes for the air handler: (1) economizer, (2) direct evaporative cooling, (3) indirect-direct evaporative cooling, and (4) indirect evaporative cooling. When outside conditions are favorable, the air handler meets cooling loads by economizing where outside air and return air (drawn from the east mid-bay) are mixed to meet a control temperature.

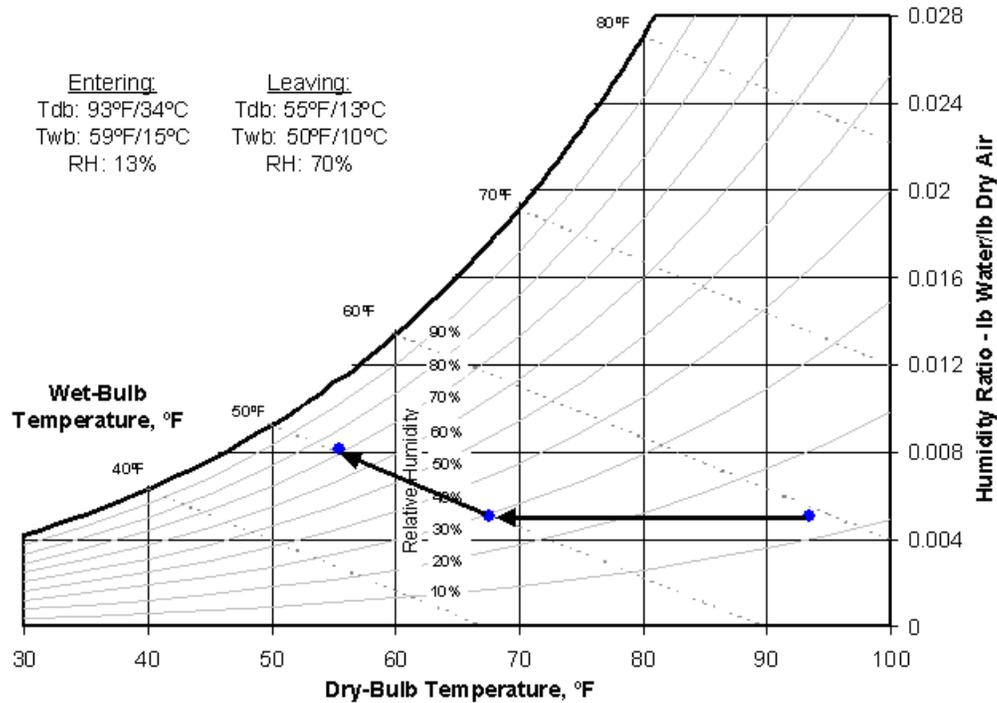
Figure 4-15 Evaporative cooler operation on a cooling design day

Figure 4-15 shows the operation of the evaporative cooler on a psychrometric chart. The 2.5% Denver cooling design day temperatures are 93°F dry-bulb/59°F wet-bulb (34°C dry-bulb/15°C wet-bulb). Under these conditions, the indirect section of the evaporative cooler is able to supply air at 67°F dry-bulb/50°F wet-bulb (20°C dry-bulb/10°C wet-bulb). Operating the direct section of the evaporative cooler reduces the supply air temperature further to 55°F dry-bulb/50°F wet-bulb (13°C dry-bulb/10°C wet-bulb).

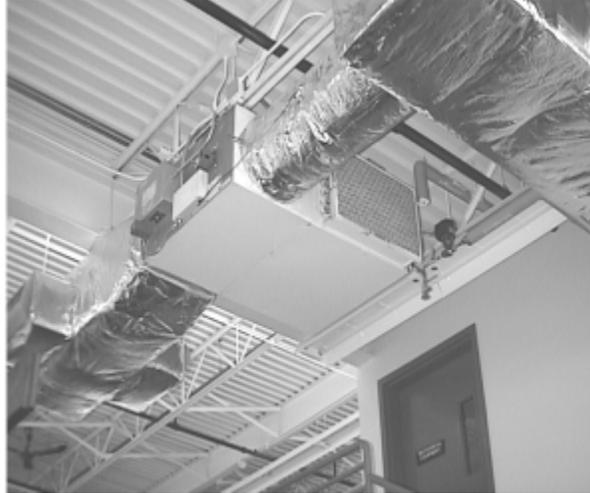
Figure 4-16 Parallel terminal boxes allow for heating without operating main air-handler
